THE FUTURE COATING FOR OFFSHORE RIGS AND SHIPS

NEW CERAMIC COATINGS ON METALIC SURFACES INTRODUCTION

CERAMIC COATING REAL SEA TEST in TECNALIA'S HARSHLAB RIG

2023089 KERACOAT HARSHLAB MICROSCOPIC ANALYSIS

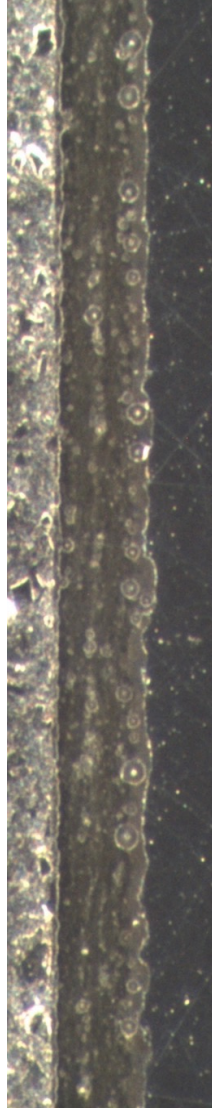
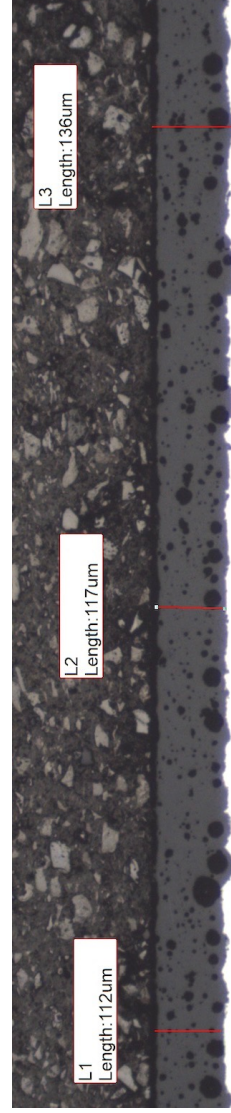
PLATE 1L

DIFFUSION AREA : a bit in the BIG side but around standard

Average thickness :
122 microns, a bit low Hand made

Bubble structure: GOOD Goods ize average and no big ones close to Surface

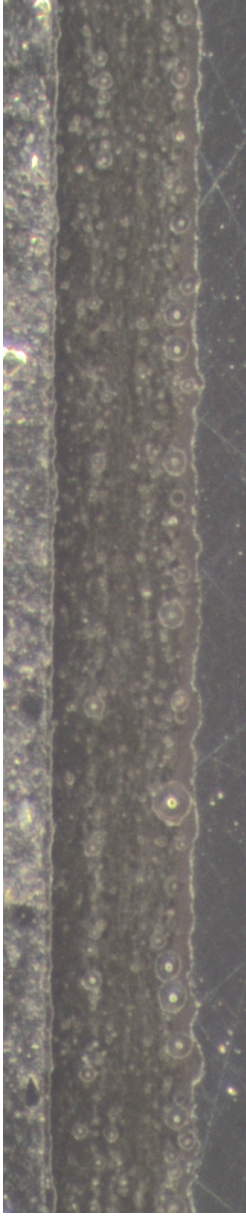
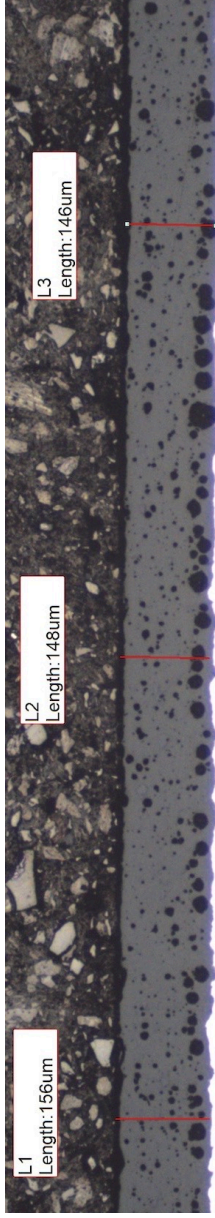
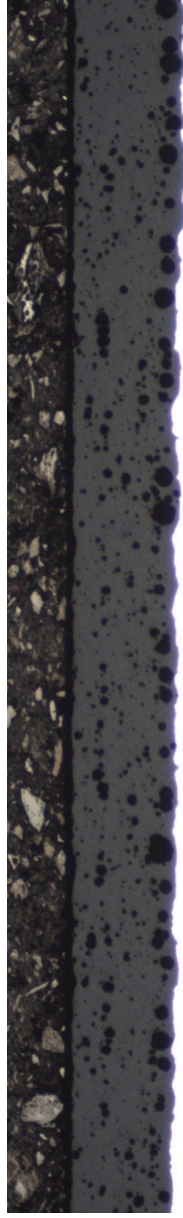
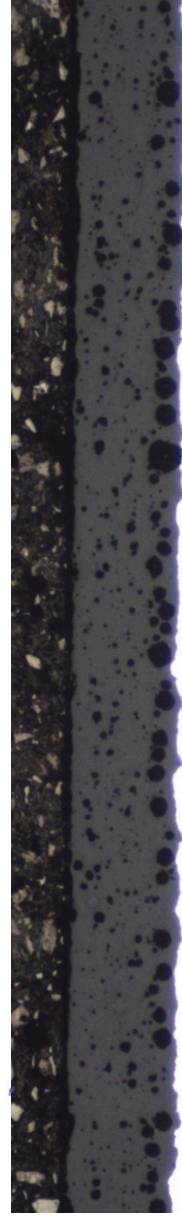
DIFFUSION AREA : a bit in the BIG side but around standard

Average thickness :
150 microns

Bubble structure: very Good .

Average size, medium- small and closer to the Steel .

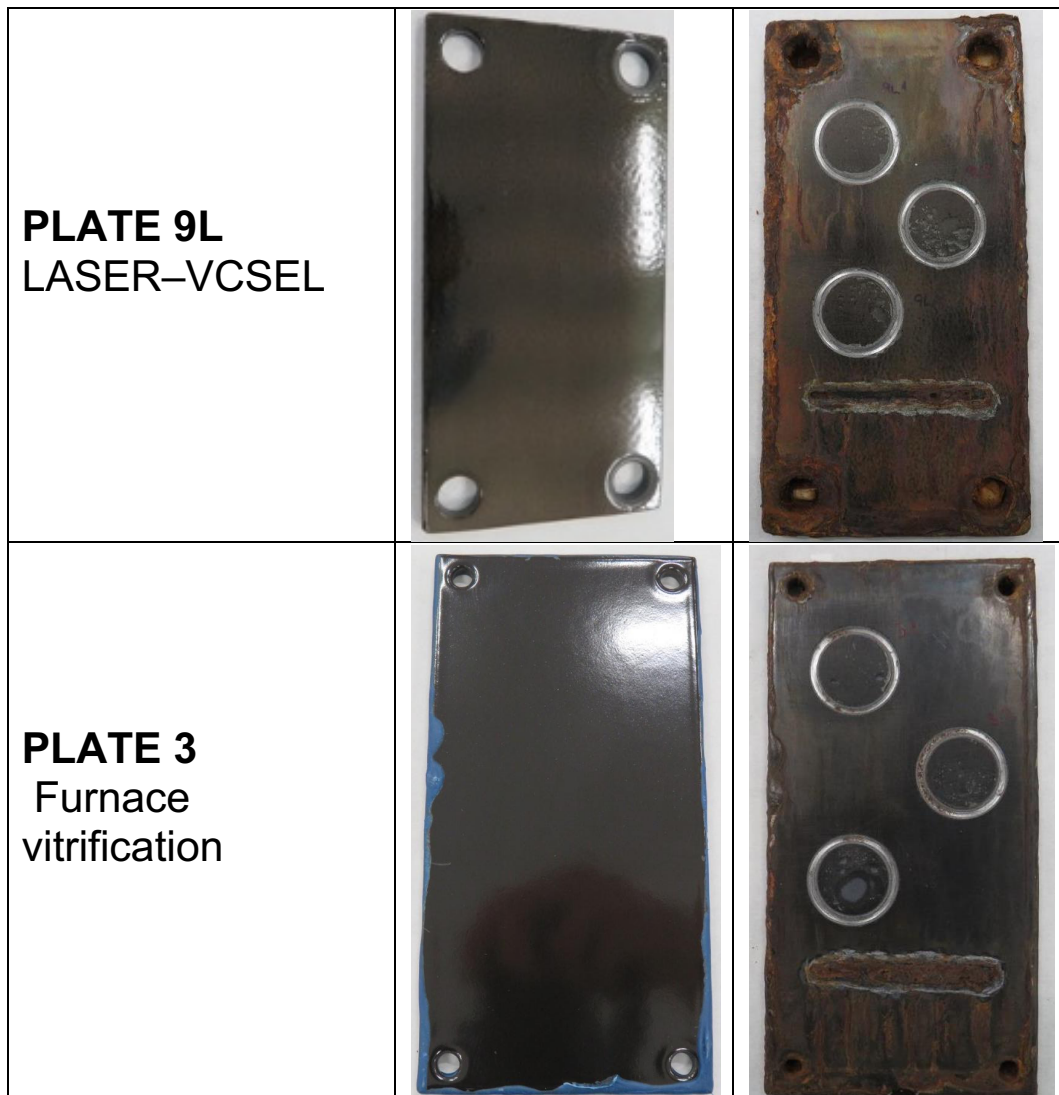
a) The only oxidation observed was in the sharp edges and in the scar, as there is no coating there : NO OXIDATION ON THE SURFACE

b) Adherence as per UNE-EN-ISO 4624:2016 VERY GOOD , see the particular test explanation of the Pull-off test

d) There are no differences due to the diverse vitrification processes.

- Sharp edges: Ceramic and may other coatings present defective points in very sharp edges son in the industrial processes all edges must be rounded to $R > 4$ mm aprox

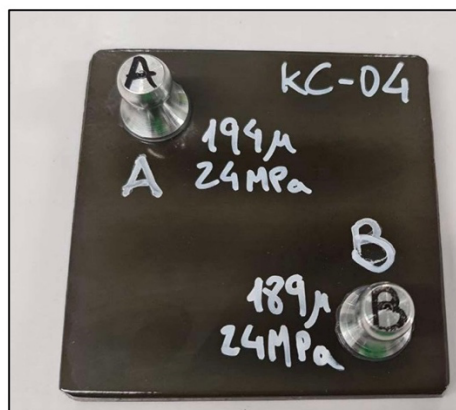
Tested in a Wind tower manufacturer in Bilbao HAIZEAWIND, they stopped the test at 24 Mpa: as that was the max pulling force of the testing machine and the coating WAS NOT BROKEN

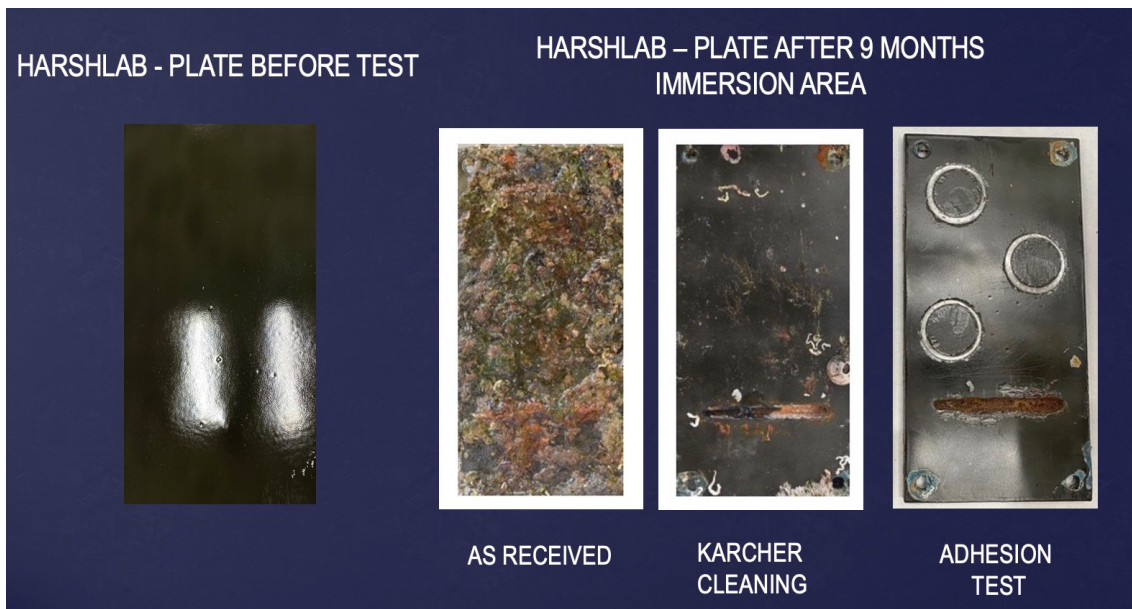
FOULING – After 9 months there were algae and some cirripeds over the the plates , mainly in the submerged area.

That fouling was easily cleared with a domestic water jet at 300 bar (Kärcher) and the ceramic was in a perfect smooth condition
