CORROSION AND FOULING RESISTANCE IN HIGH TEMPERATURE ENVIRONMENTS
TEMPERATURE > 450°C (850°F)

COATING FOR VANADATE ATTACK RESISTANCE IN A COKE CALCINER HEAT RECUPERATOR

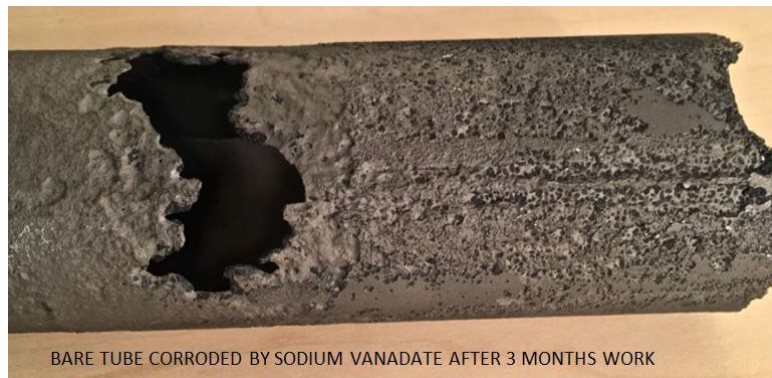
Figure 1 State of the Art 2014 - Substrate AISI310

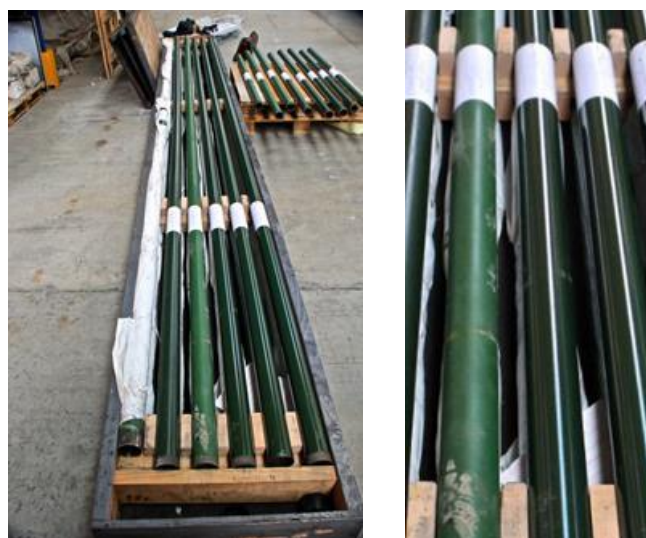
After promising results with small samples, a first batch of real size tubes has been sent for **one year** trial in a US refinery (see *Figure 2*)

Figure 2 - Tubes 6m longer coated by Kera-Coat/IK4-Cidetec

9 coated tubes with our ceramic K-100 were placed in the upper row (the hottest) of the #3 calciner recuperator on May 2015.

Oil fumes rich in vanadates are measured at 700°C (1300°F) and metal surface is estimated at 550°C (1000°F)

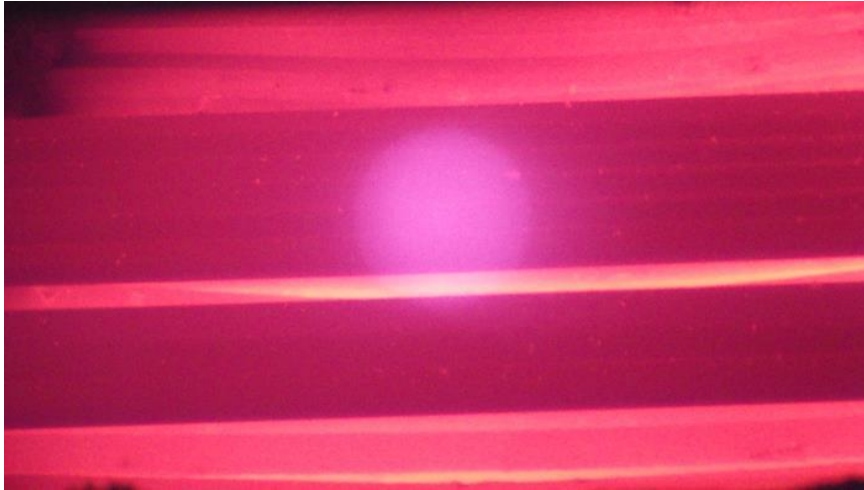
The situation of this heat exchanger after 10 months in operation was clearly shown in these pictures:

Figure 3- July 2015 (3 months working)

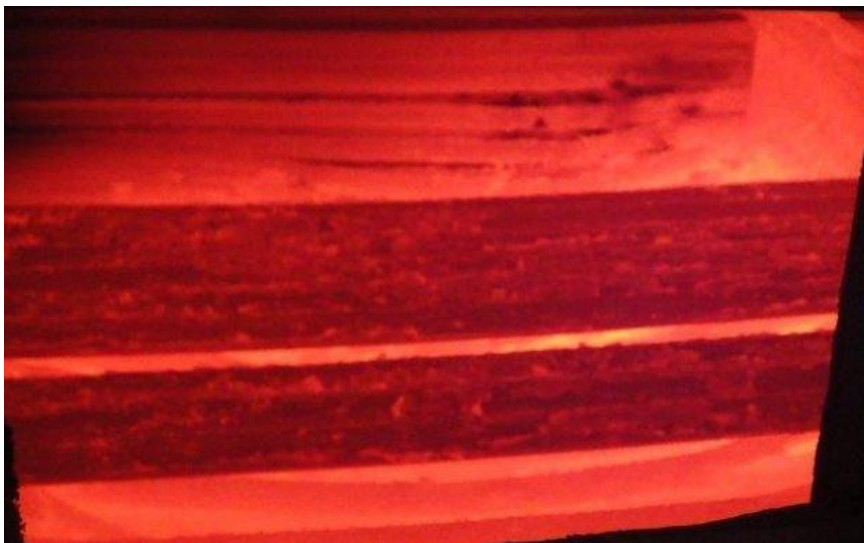
Figure 4- 2015 October (6 months working)

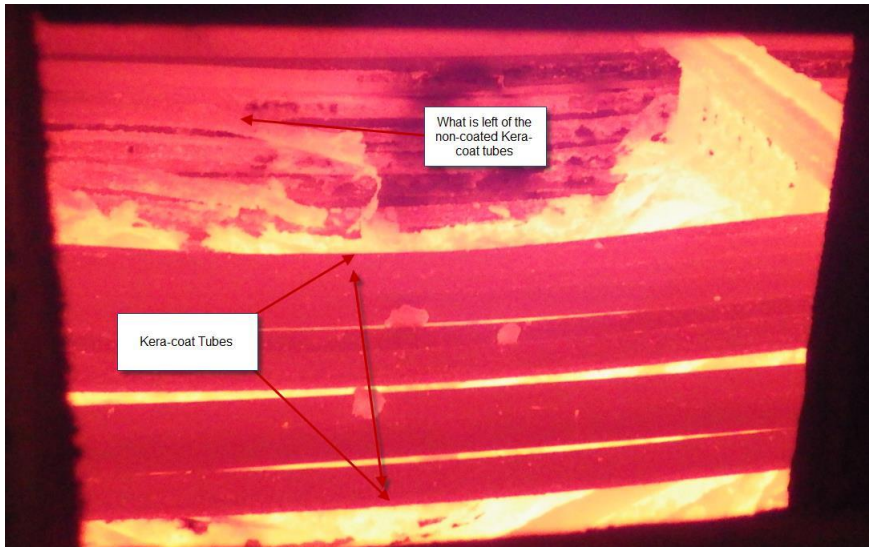
Figure 5 - 2016 February (10 months working)

Only the 9 coated tubes were remaining in the area, the rest were broken and blinded, so most of the passing air went thru the survives on the lower part of the exchanger

The remaining coated tubes suffered an overheating during the last weeks of operation and specially one of them that got bowed

This one was taken out beginning March 16, the rest were left in position and continue on service.

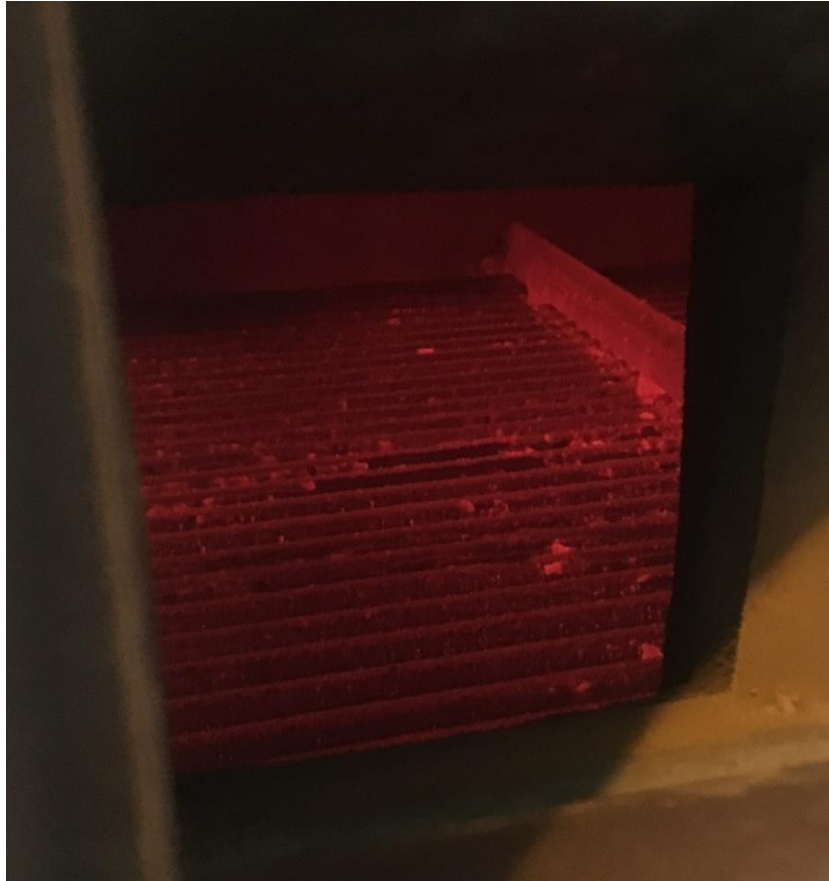
Figure 6

After 5 months operation Ceramic Coated Tubes are in perfect shape, without any damage in their surface, only some ash deposits (light points) most likely flying flakes ... as they do not seem to be making any build up on the tube "shoulders"

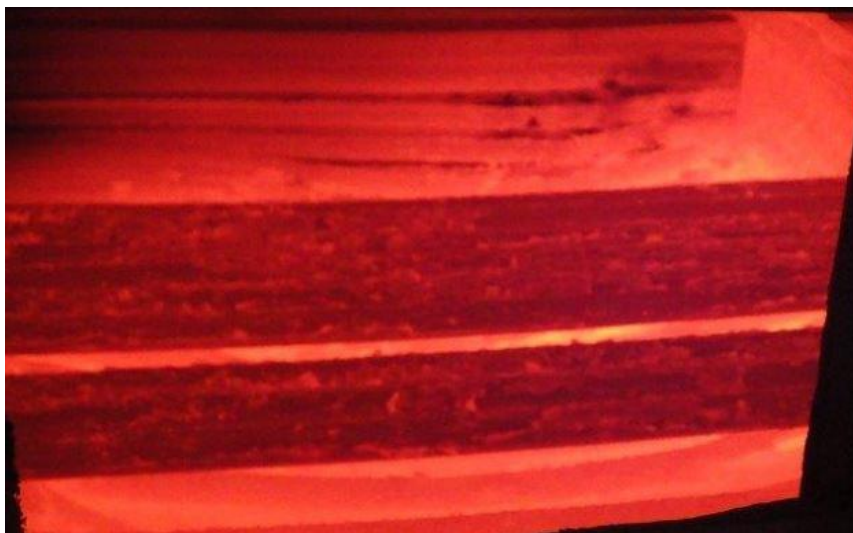
Figure 7

Comparing with the previous arrangement – in the same operational time – where only a few tubes were coated (TWO OF THEM IN THE FOREGROUND)... the difference is outstanding.

Last year, with only 9 scattered COATED tubes among more than 800 bare tubes, many of the last ones where so corroded that air was already leaking thru many holes in their upper “shoulder” thus overheating the tube steel and further increasing the corrosion rate

More and more air was escaping thru the open holes and ALL tubes were losing “refrigeration” and getting hotter and hotter

NEVERTHELESS ... AFTER 10 MONTHS SERVICE THE 9 COATED ONES WERE WITHOUT ANY HOLE and still fully operational

Now with the whole set of 830 coated tubes... the recuperator works as new after 5 months which previously meant the 70% of the allowed life.

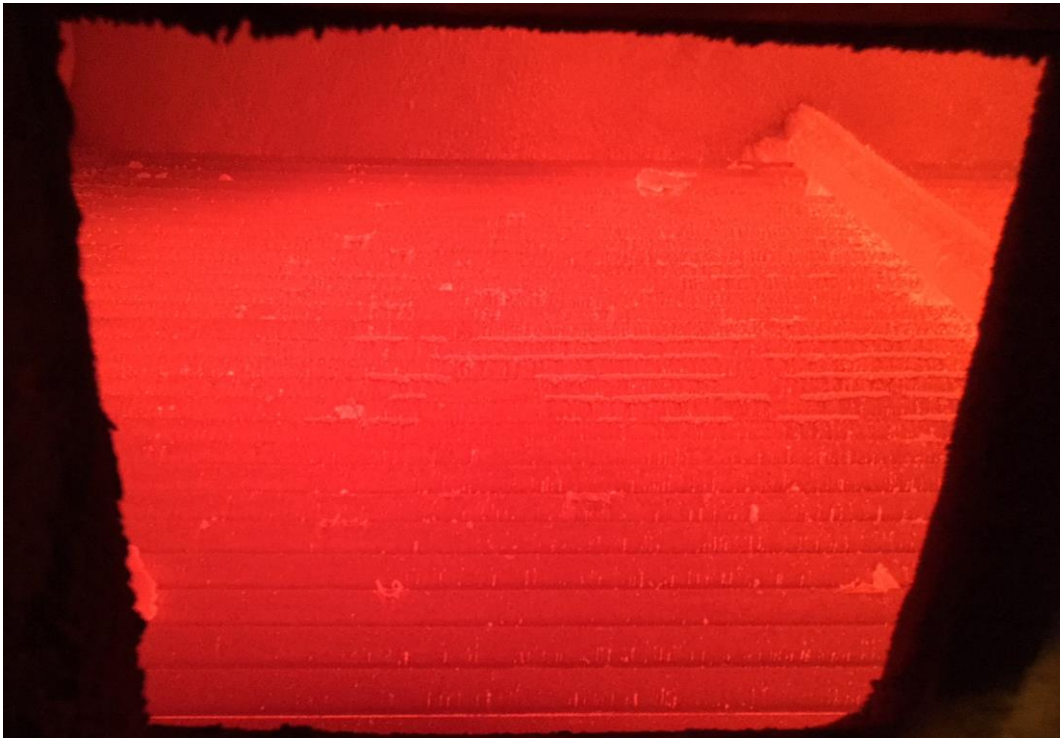
Figure 8

After 10 months operation Ceramic Coated Tubes are in perfect shape, without any damage in their surface, only some ash deposits (light points) most likely flying flakes ... as they do not seem to be making any build up on the tube “shoulders”

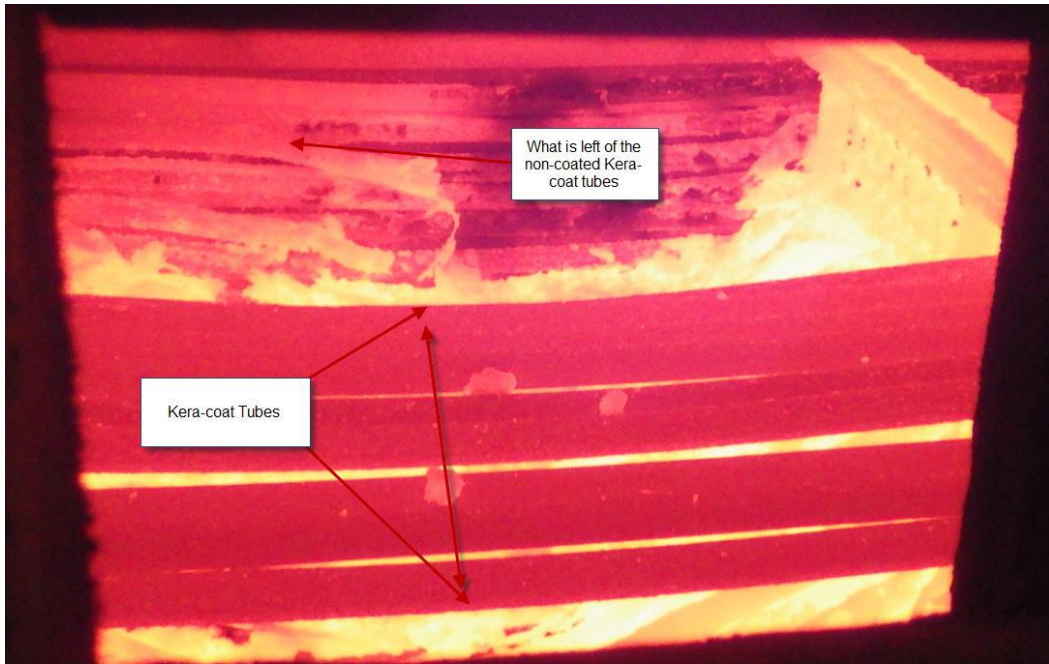
Figure 9

Comparing with the previous arrangement – in the same operational time – where only a few tubes were coated (TWO OF THEM IN THE FOREGROUND)... the difference is outstanding.

Last year, with only 9 scattered COATED tubes among more than 800 bare tubes, many of the last ones were so corroded that air was already leaking thru many holes in their upper "shoulder" thus overheating the tube steel and further increasing the corrosion rate

More and more air was escaping thru the open holes and ALL tubes were losing "refrigeration" and getting hotter and hotter

NEVERTHELESS ... AFTER 10 MONTHS SERVICE THE 9 COATED ONES WERE WITHOUT ANY HOLE and still fully operational

Now with the whole set of 830 coated tubes... the recuperator works as new after 10 months which previously meant the 95% of the allowed life.
