THE FUTURE COATING FOR OFFSHORE RIGS AND SHIPS

NEW CERAMIC COATINGS ON METALIC SURFACES INTRODUCTION

CERAMIC COATING REAL SEA TEST in TECNALIA'S HARSHLAB RIG

2023089 KERACOAT HARSHLAB MICROSCOPIC ANALYSIS

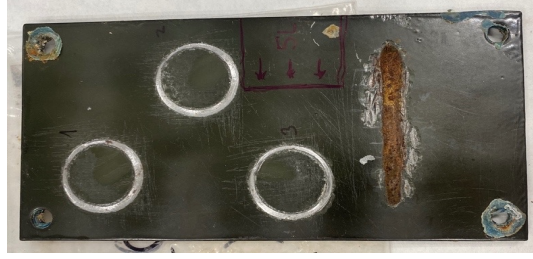
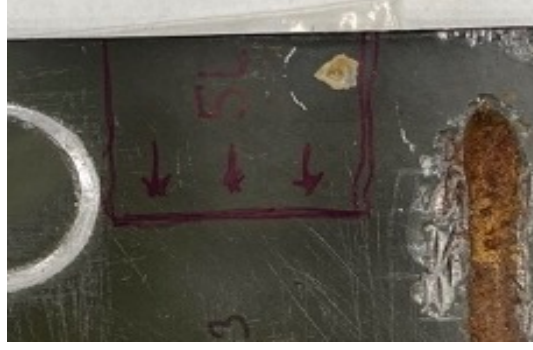
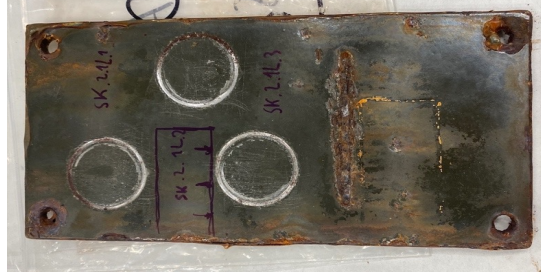
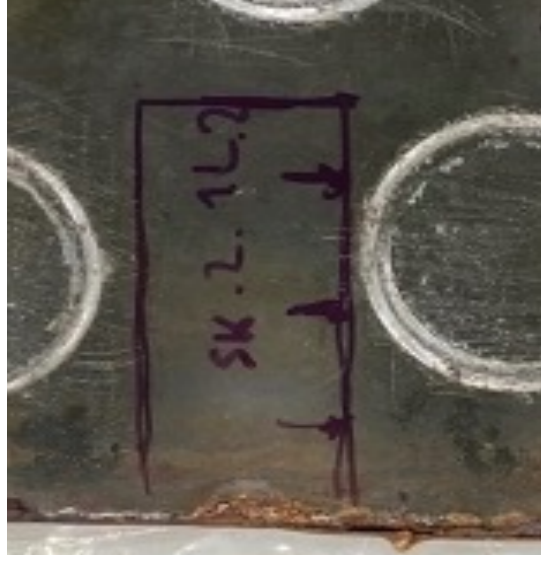
Target is to inspect the bubble structure after 9 months at sea in the Harshlab rig immersion & splash zones.

Two plates, 1L & 5L LASER vitrified are inspected

Marks indicate the cut areas from where the probes were taken

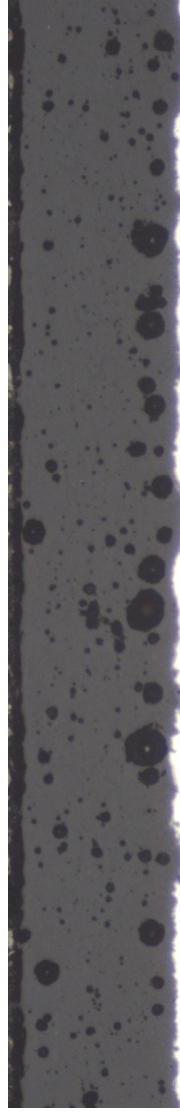
Bubble structure: GOOD Goods ize average and no big ones close to Surface

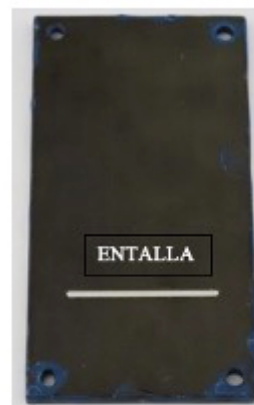
ENTALLA: SCAR or scribe made by artificial means

a) The only oxidation observed was in the sharp edges and in the scar, as there is no coating there : NO OXIDATION ON THE SURFACE

- Sharp edges: Ceramic and may other coatings present defective points in very sharp edges son in the industrial processes all edges must be rounded to $R > 4$ mm aprox

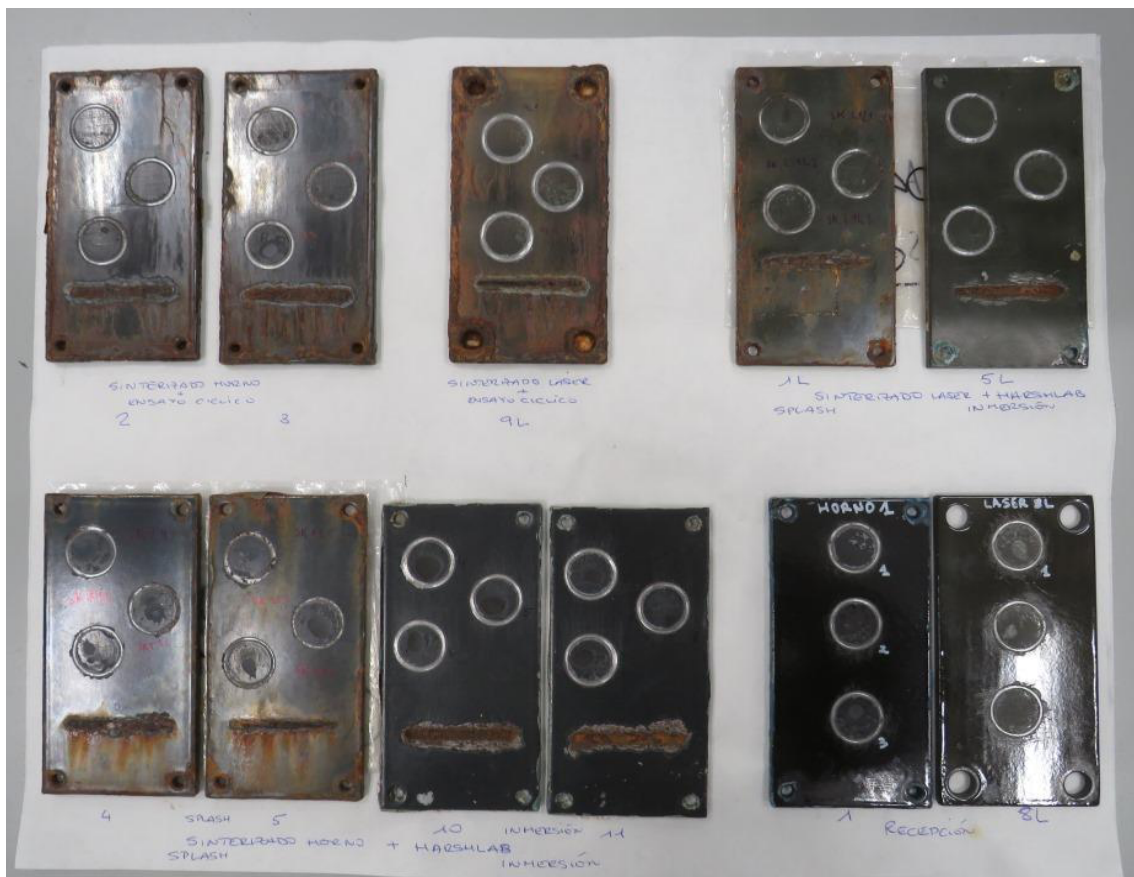
SCAR (ISO4628-8:2012 *Evaluation of degradation of coatings. Designation of quantity and size of defects, and of intensity of uniform changes in appearance. Part 8: Assessment of degree of delamination and corrosion around a scribe or other artificial defect.*): Horizontal Scars were made before the sea test to evaluate possible undercoating corrosion evolution and the results have been excellent

- Maximum growth allowance: 8 mm
- Lab results: 2 mm
- Sea test results: 0 mm

Round machined circles were made after the test to evaluate the coating's adherence.

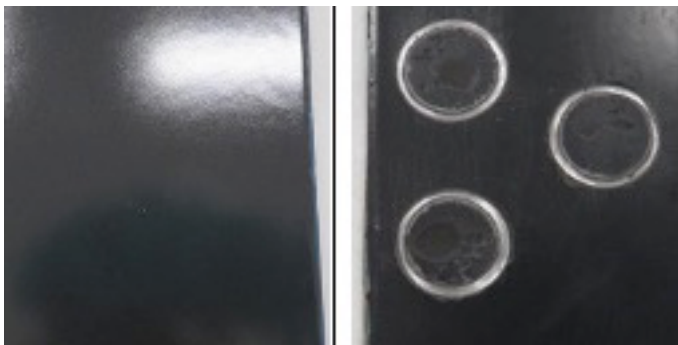
In this norm the pulling part is glued to the coating and the area around that pulling part is machined to separate the pulled part from the rest of the coating as in the picture below

Tested in a Wind tower manufacturer in Bilbao HAIZEAWIND, they stopped the test at 24 Mpa: as that was the max pulling force of the testing machine and the coating WAS NOT BROKEN
